## Phantor 10.000

Description of the current condition incl. photo documentation.

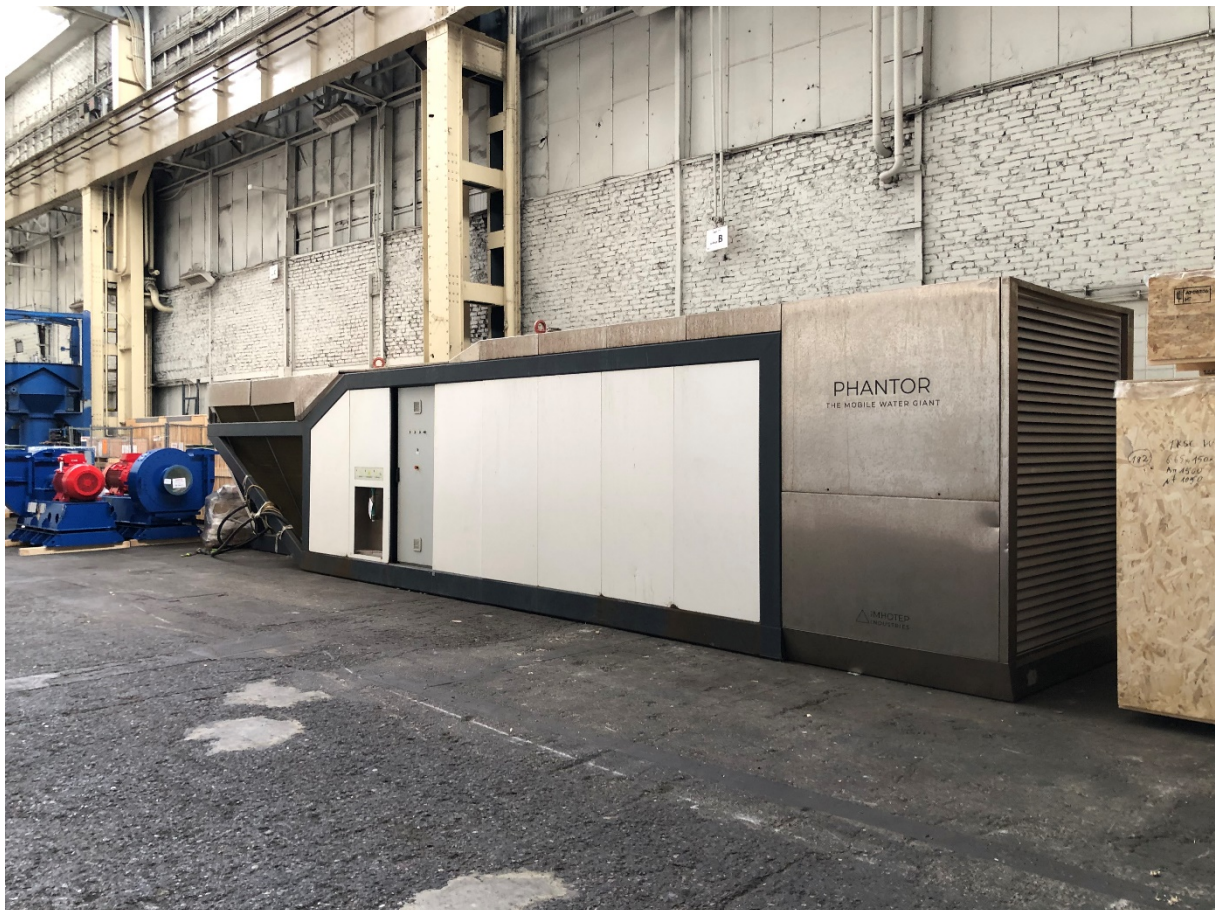
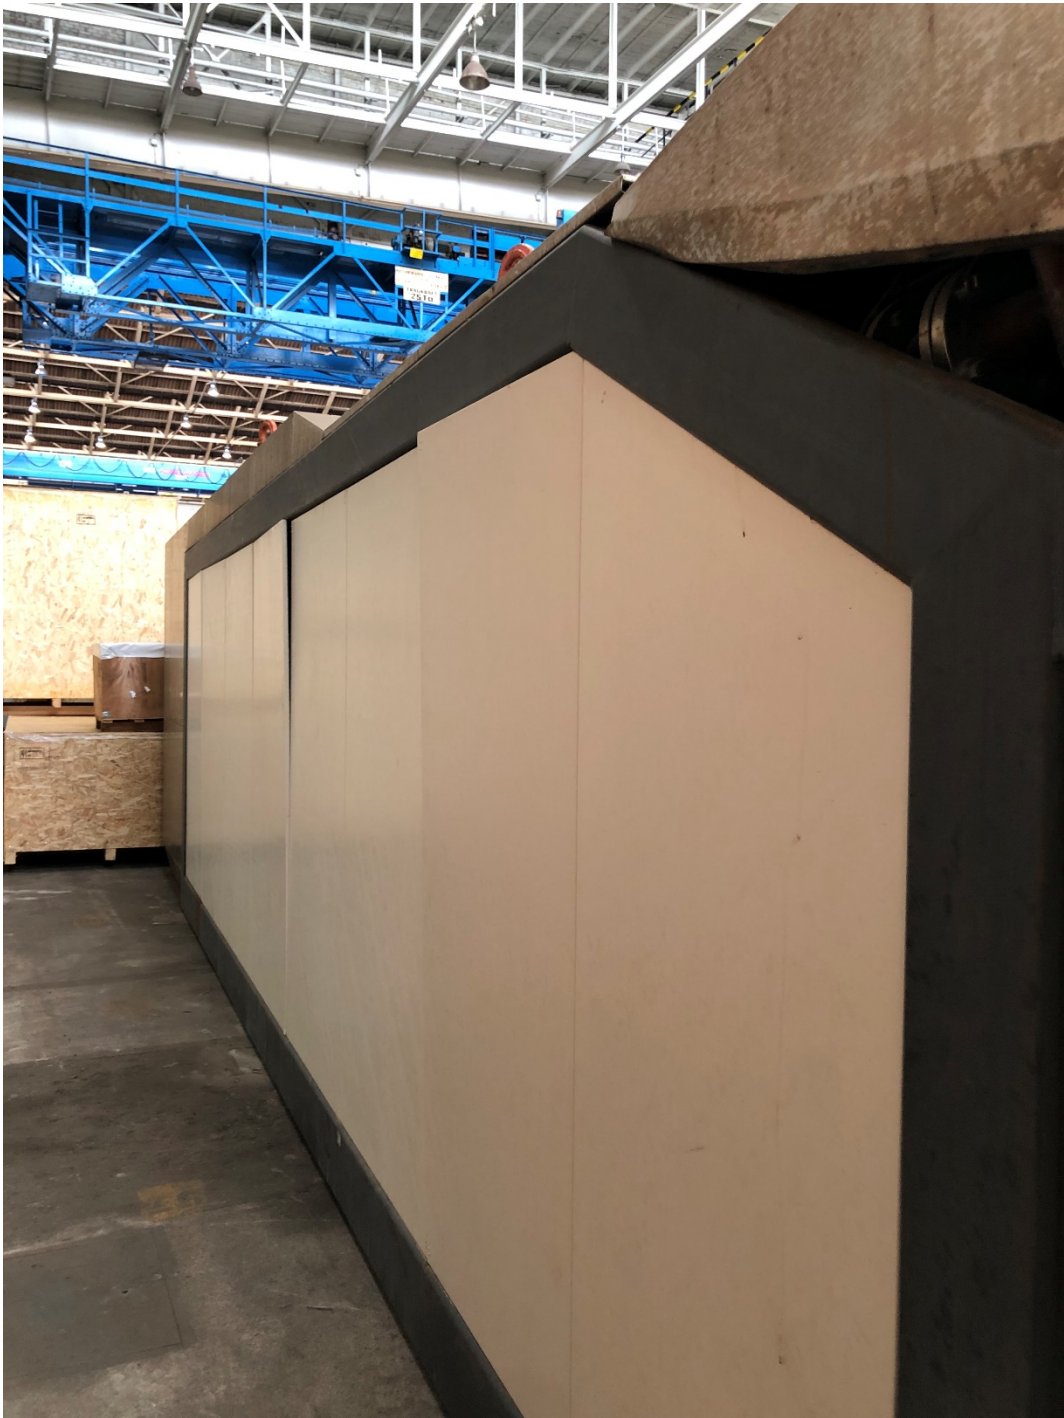
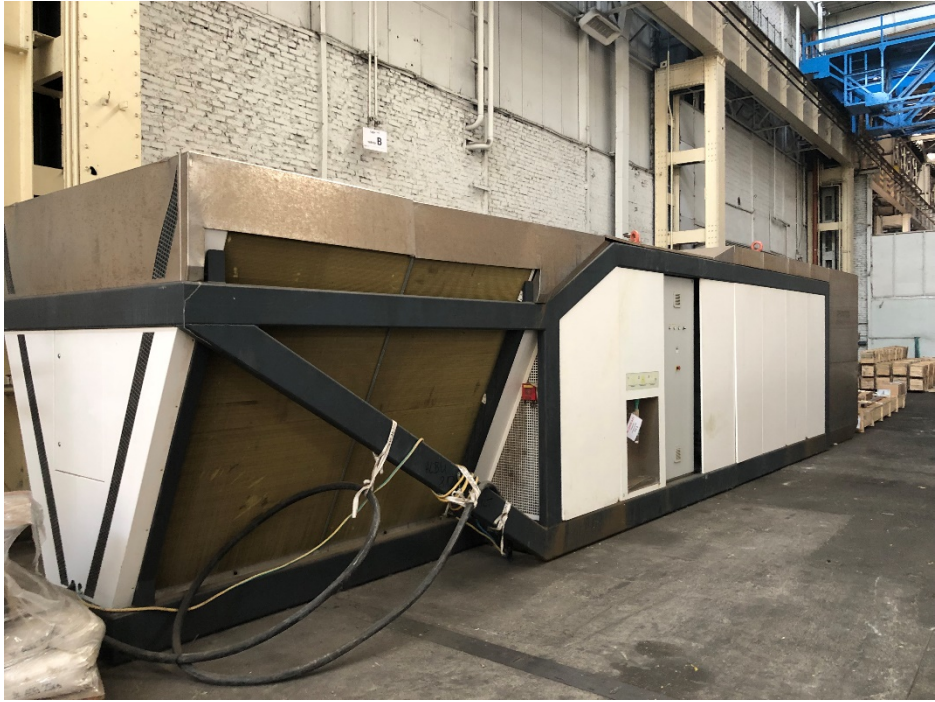
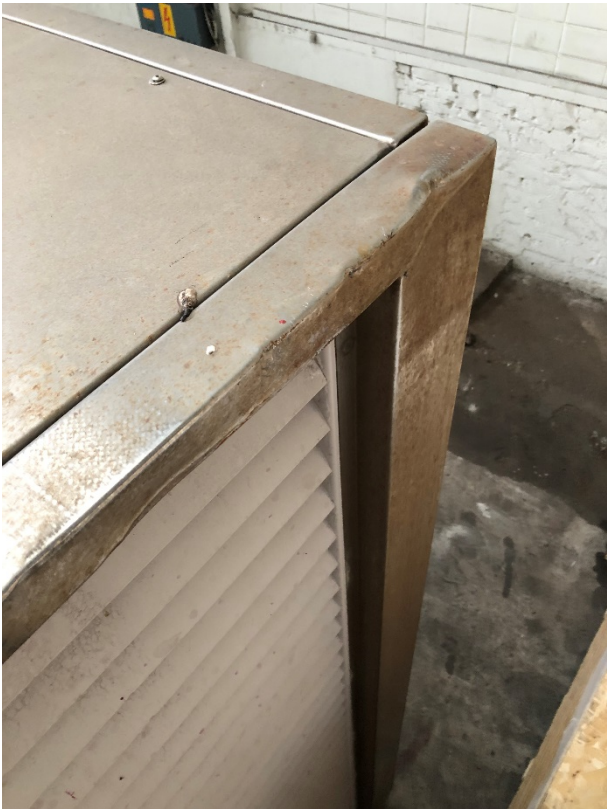
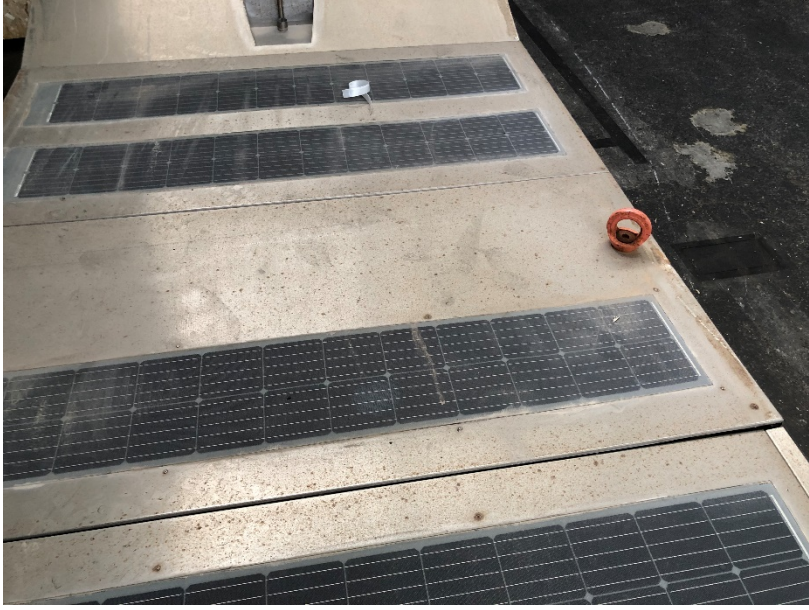
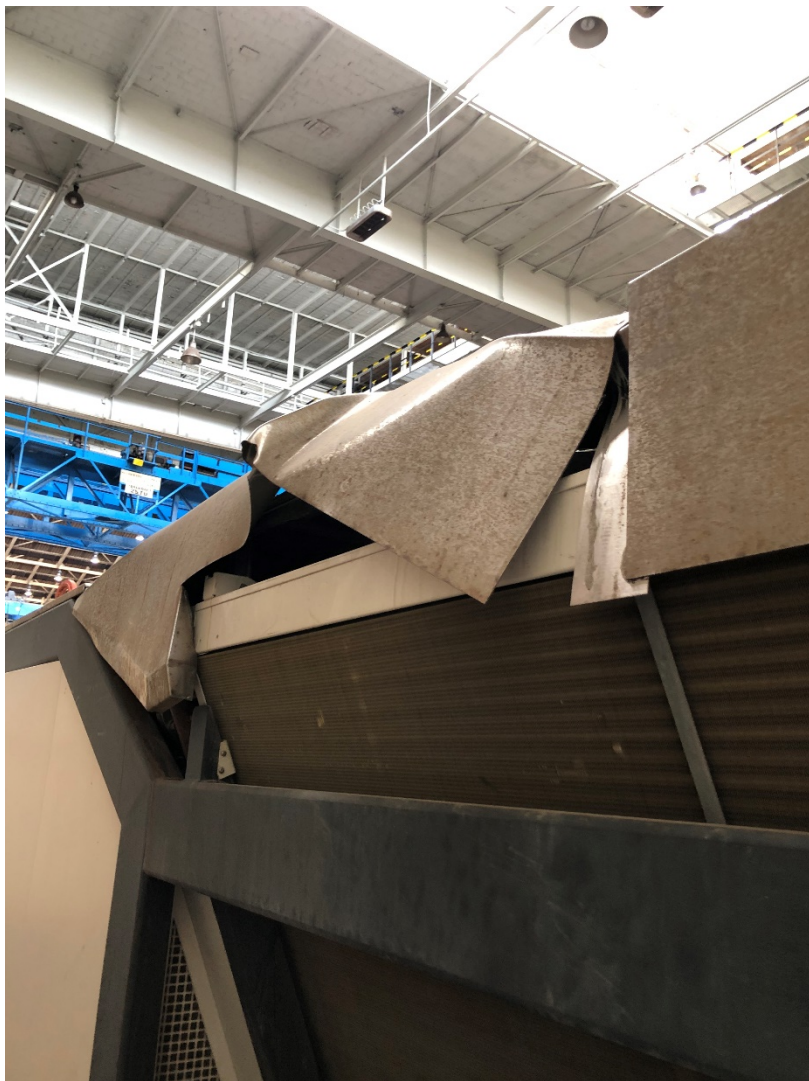
In total, the system was in operation for approx. 500 hours. Due to the careless/careless handling in Dubai (no maintenance/operation/care/cleaning for 2 years), the system is very worn out.

The stainless steel parts are all showing signs of rust. The interior is completely covered with dust and sand, as the system was not operated for 2 years and therefore there was no overpressure in the interior.

During the return transport from Jebel Ali to Linz in Q2 24, there was transport damage which destroyed many areas of the Phantor's cladding.

In principle, the Phantor cannot be used in this condition - the entire casing would have to be replaced and the system would have to be thoroughly cleaned and tested to determine the extent to which the individual components have been damaged or are still functional.

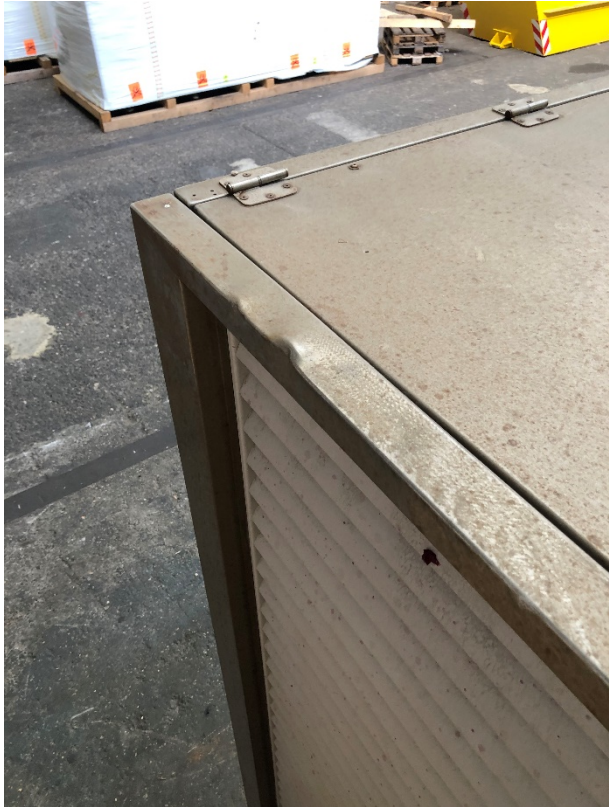
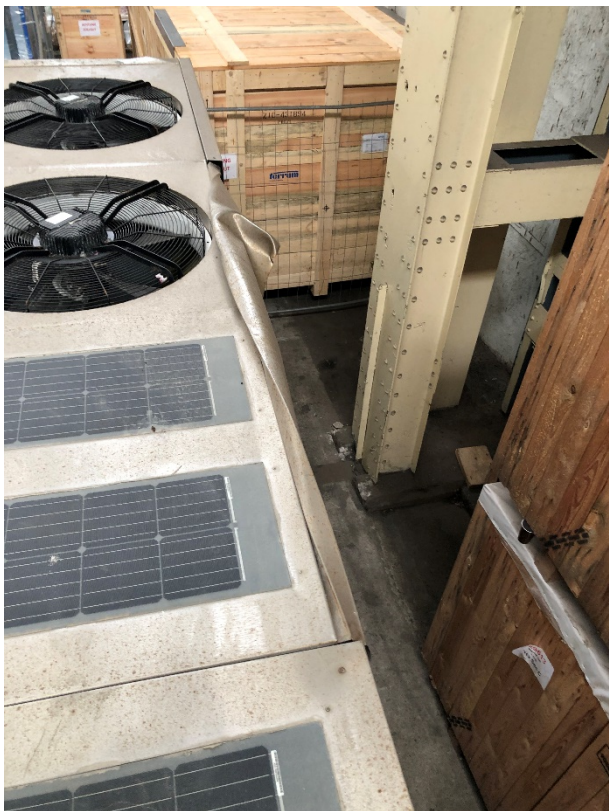
Ansicht: Schaden Ansaugung oben links
